**Re: Benning Facility Consent Decree (Civil Action No. 1:15-cv-018450) - Quarterly Status Report for October - December 2021**

In accordance with Paragraph 68 of the Benning Facility Consent Decree, please find attached the following reports for the period of October - December 2021:

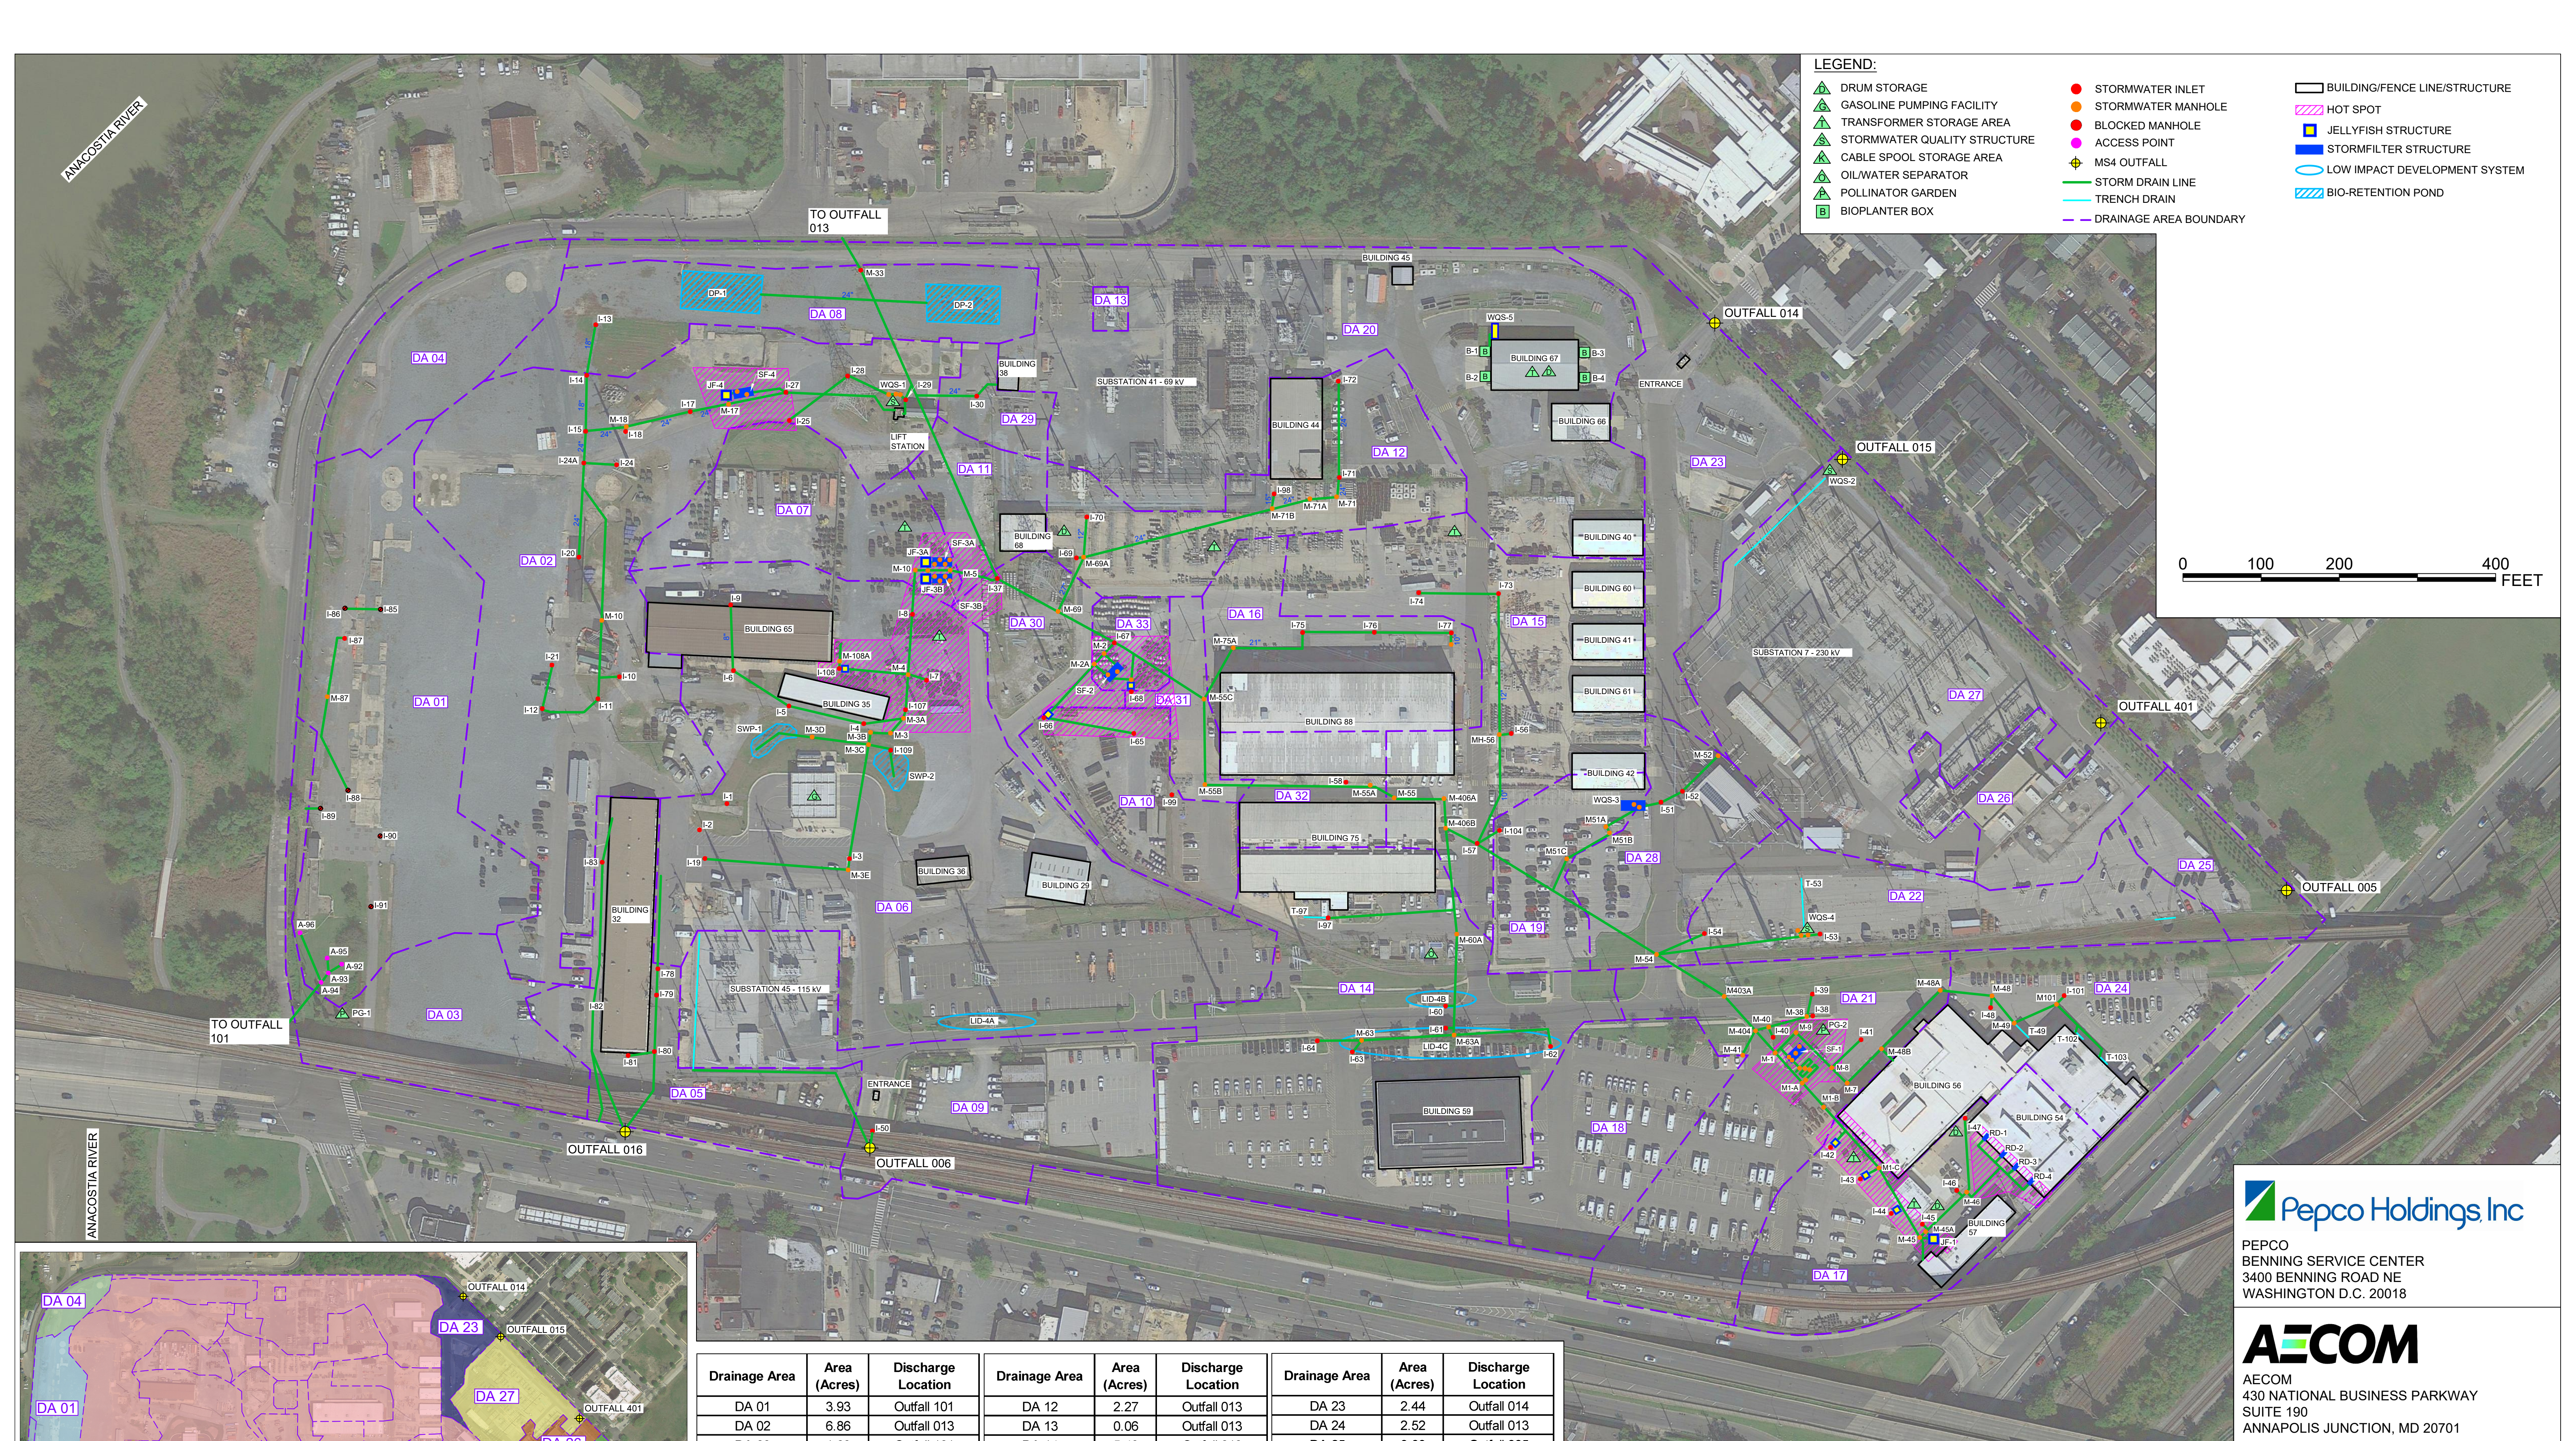
Site Drainage Drawing

The Benning Service Center's site drainage drawing was updated in December 2021, a copy of the new drawing is attached.

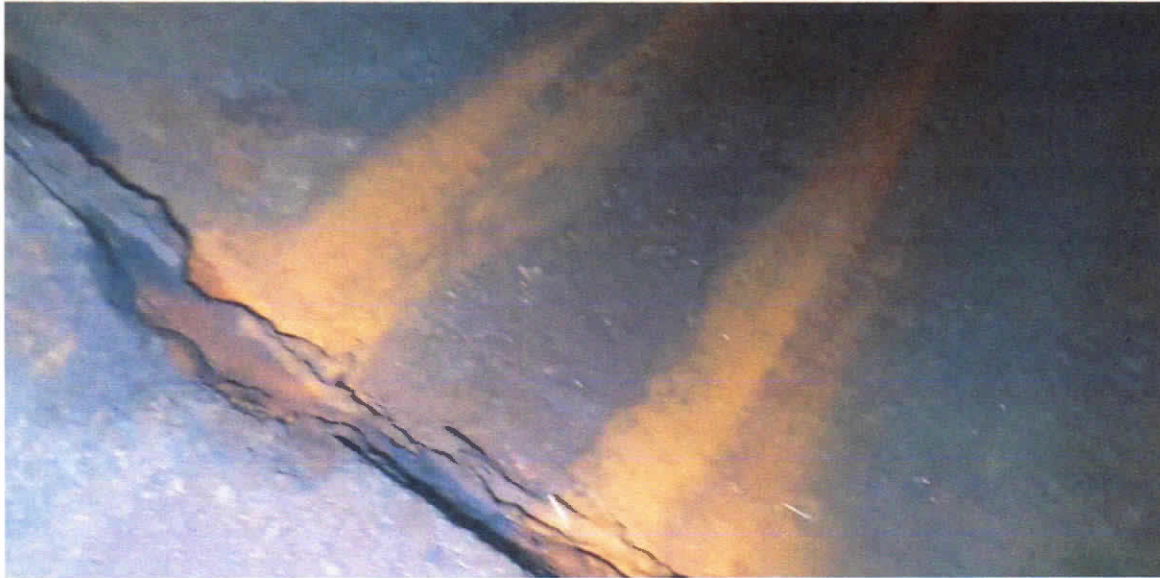
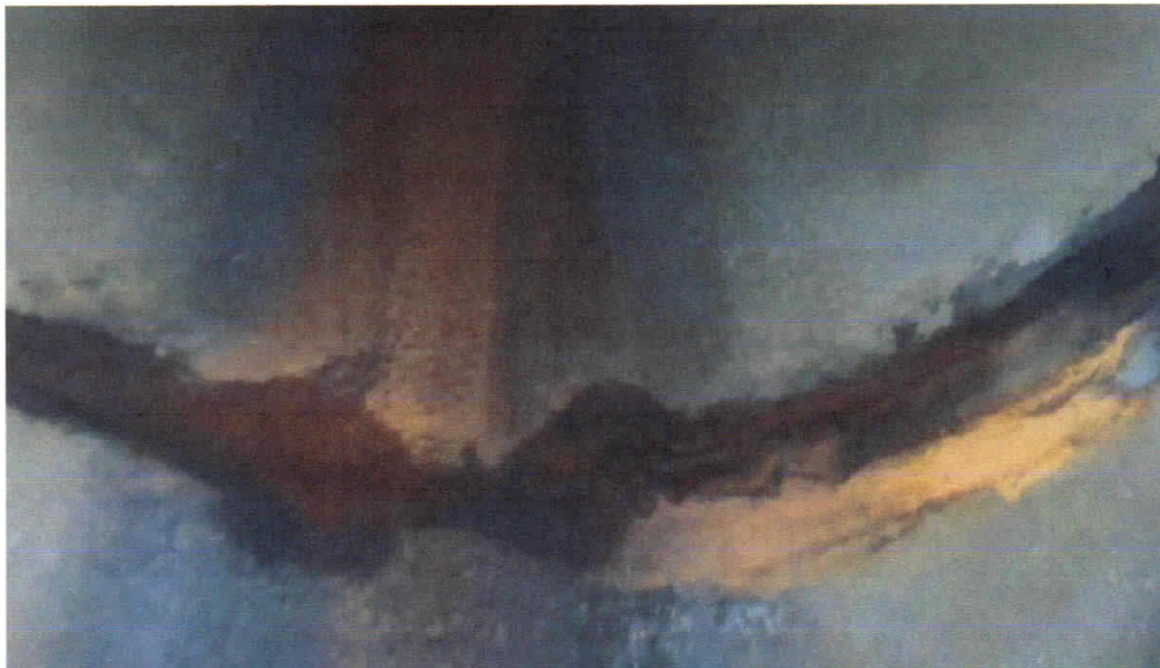
Attachment B

48" Reinforced Concrete Pipe Joints downstream of Manhole 54 showing iron staining coming from leaking joints.

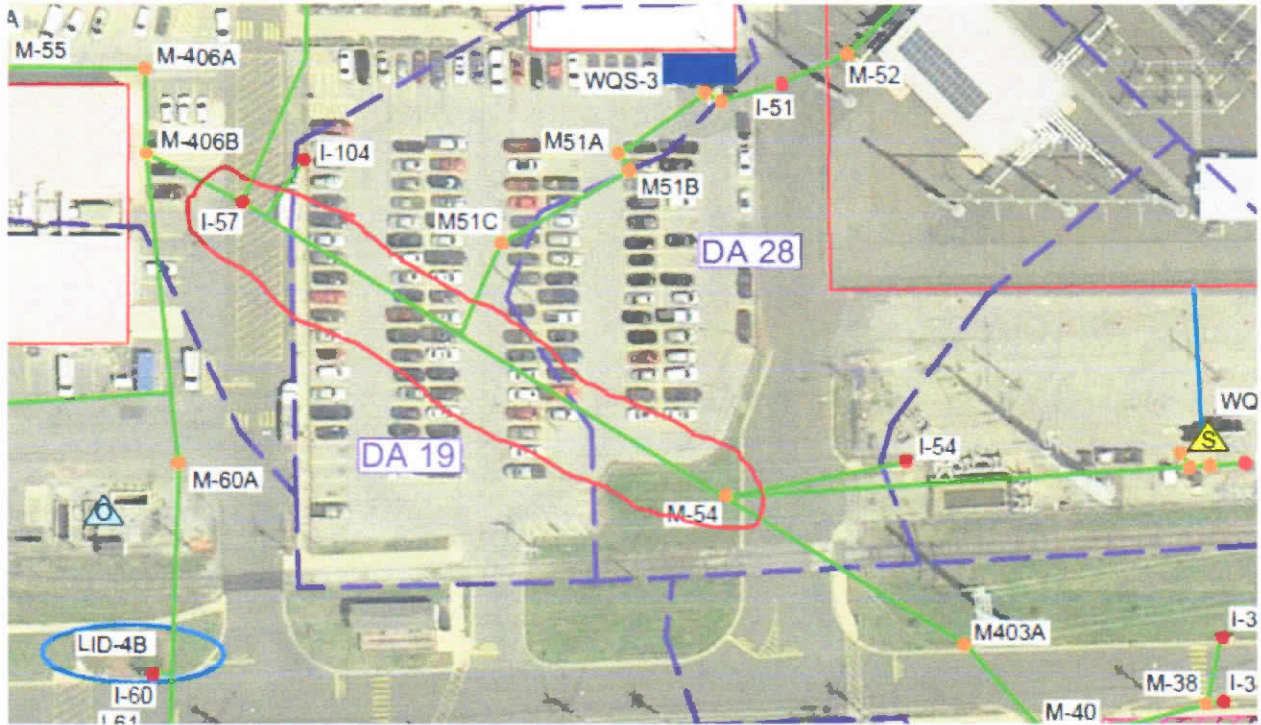
Site Map showing location (red circle) of leaking stormwater joints.
