Remedial Investigation/Feasibility Study (RI/FS) Project Update

Pepco Benning Road Facility

Presented by: Ravi Damera, AECOM Project Manager

April 2, 2016

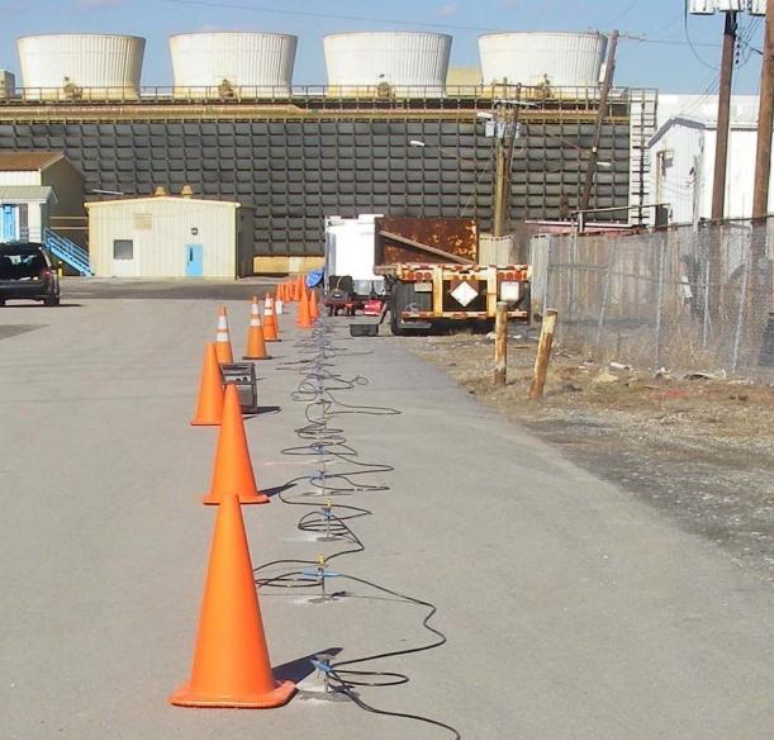
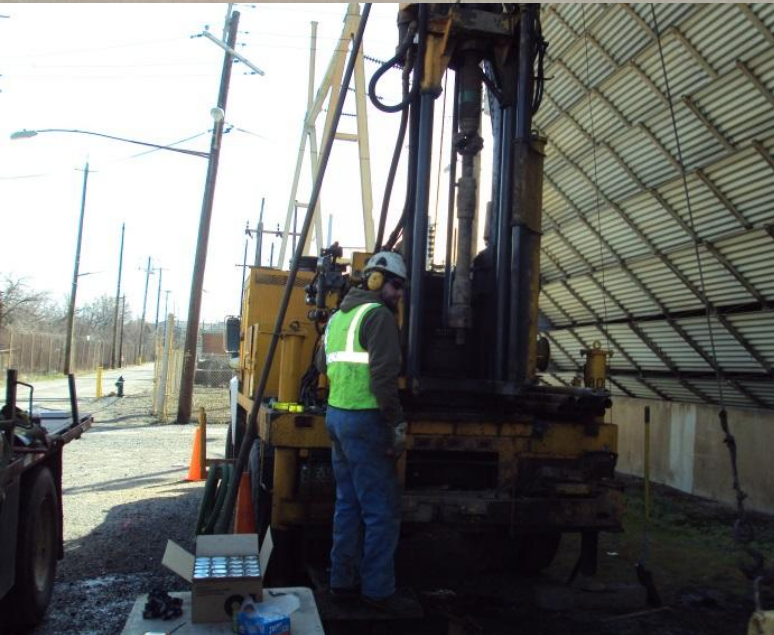
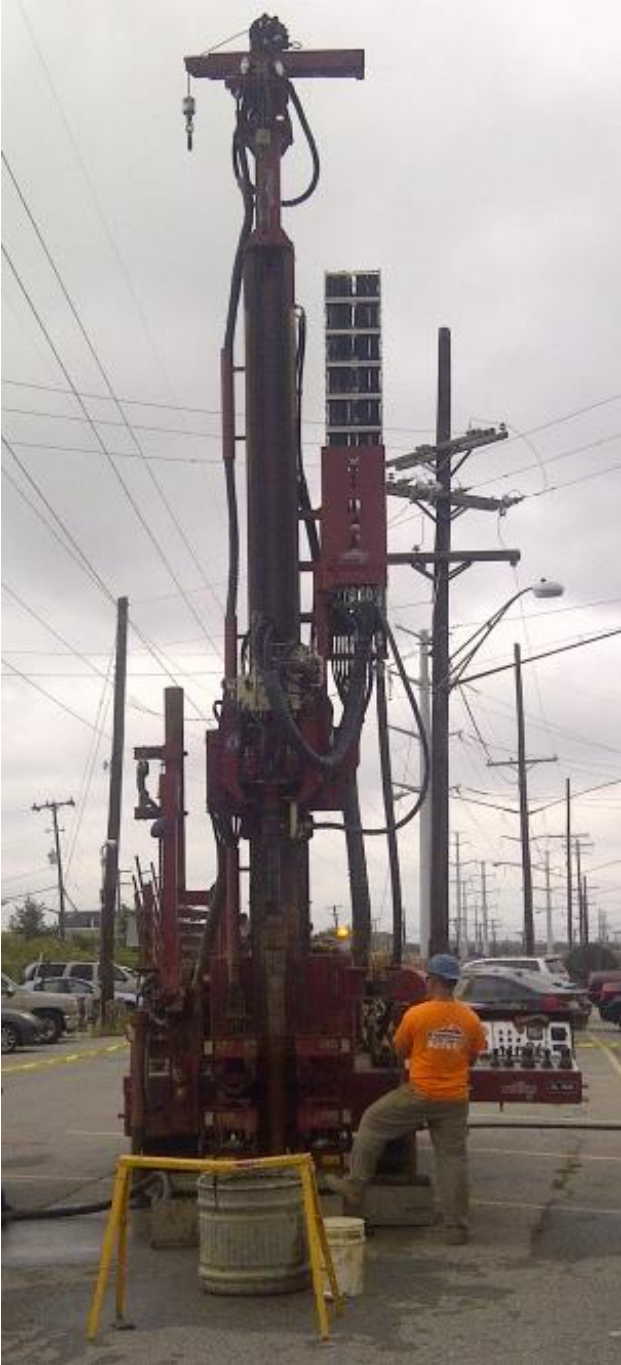
Landside Phase I – Focus on “Target Areas”

- 25 Surface soil samples to evaluate soil quality
- Electrical imaging along 10 lines to scan subsurface for utilities and gross contamination (e.g., oil-soaked soils)
- Eight water and four residue samples from storm drain inlets to assess surface water runoff quality
- Five soil borings to 60-100 ft below grade to supplement existing data
- Chemical, forensic, and geotechnical analysis of samples

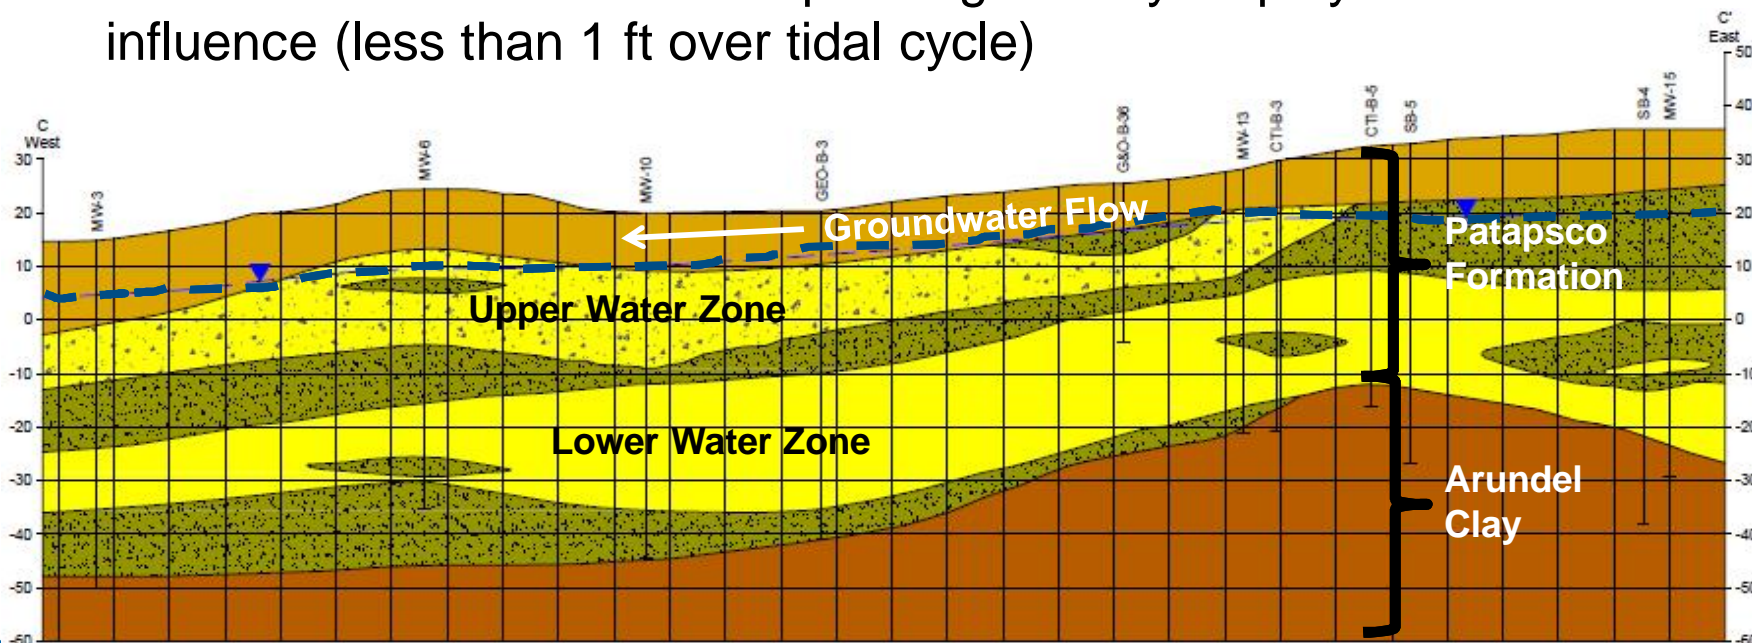
What is beneath the Site?

- There are two groundwater zones (one upper and one lower) within the Patapsco formation separated by a silt-clay layer
- Arundel Clay unit (regional feature) is located at 45 to 85 ft below grade
- Depth to the top of water table is 9-16 ft below ground surface
- Groundwater flows in both zones generally westward and discharges to the Anacostia River
- Groundwater levels in both aquifers generally display minimal tidal influence (less than 1 ft over tidal cycle)

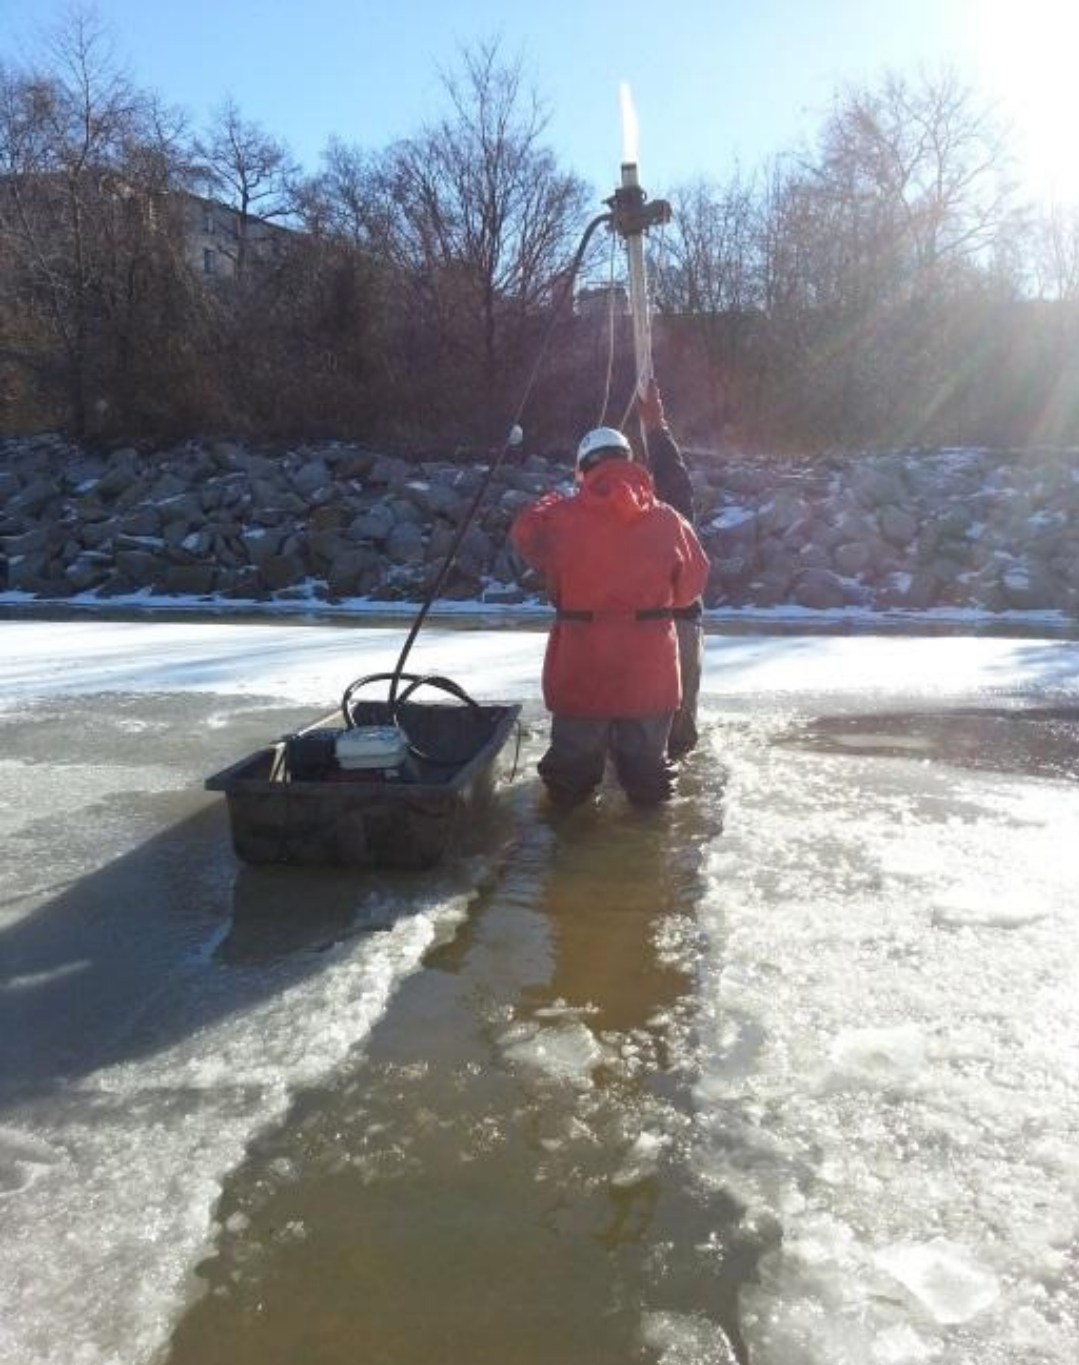
Manual sediment coring on Anacostia River mudflats in the winter of 2014

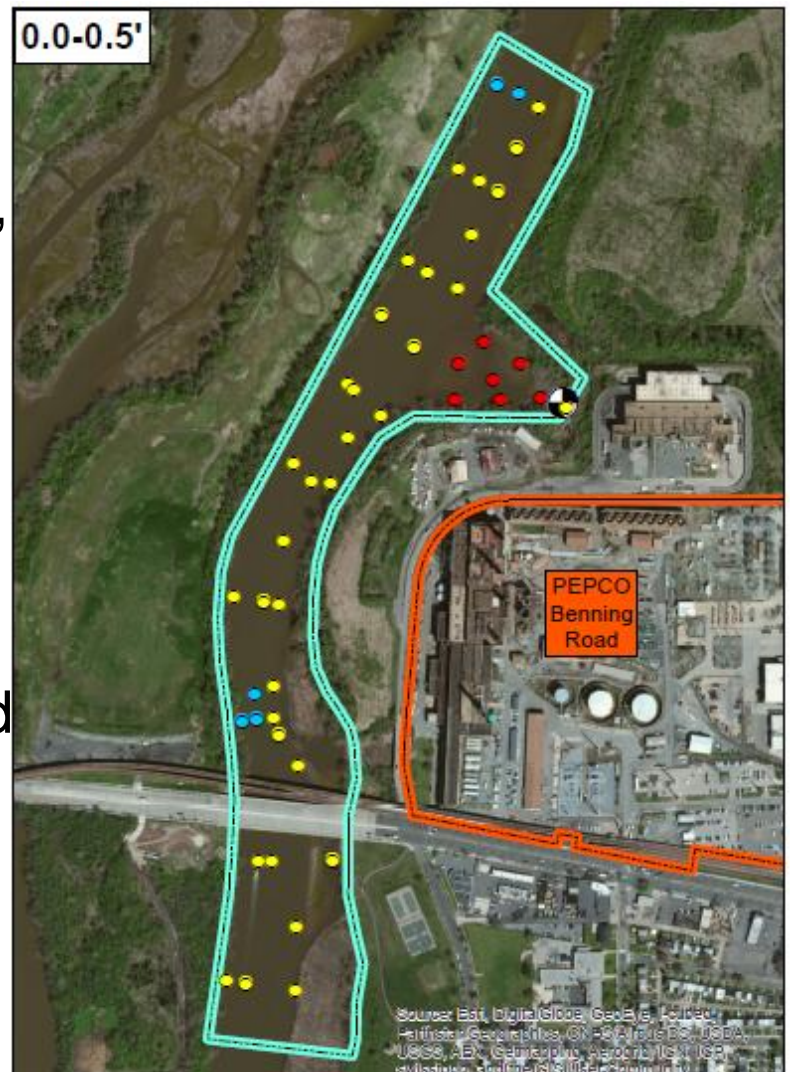
Lead Distribution in Surface Sediment

Low effect level refers to a level below which no effects are expected on the majority of population

Probable effects level refers to a level above which harmful effects are expected to occur frequently

- No exceedance
- > Low Effect Ecological Screening Value (31 ppm)
- > Probable Effect Ecological Screening Value (128 ppm)

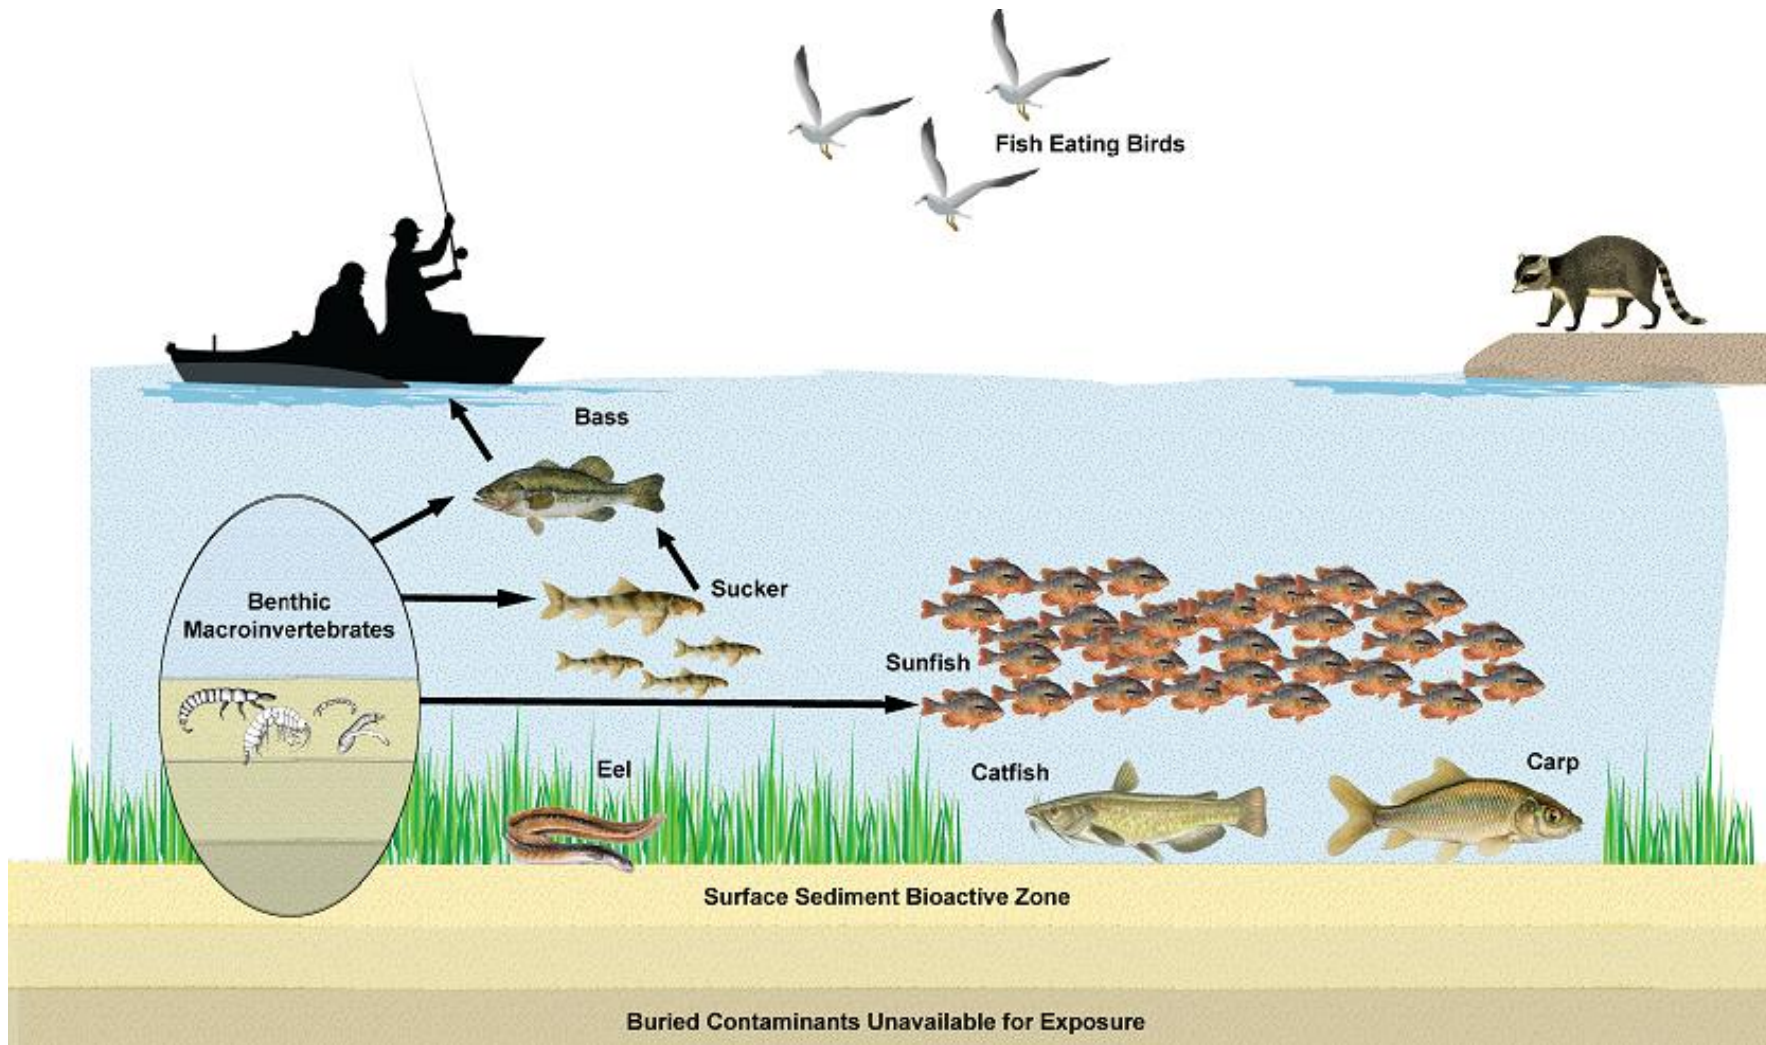
Potential Receptors and Exposure Pathways

- Two types of risk assessments: Baseline Human Health Risk Assessment (BHHRA) and Baseline Ecological Risk Assessment (BERA)
- Objective: To evaluate exposure to chemicals in –
 - Landside soil and groundwater
 - Anacostia River surface water, sediment, and fish
- Followed EPA Human Health and Ecological Risk Assessment Guidance for Superfund sites
- Results are preliminary; risk assessments will be updated following the additional field investigation

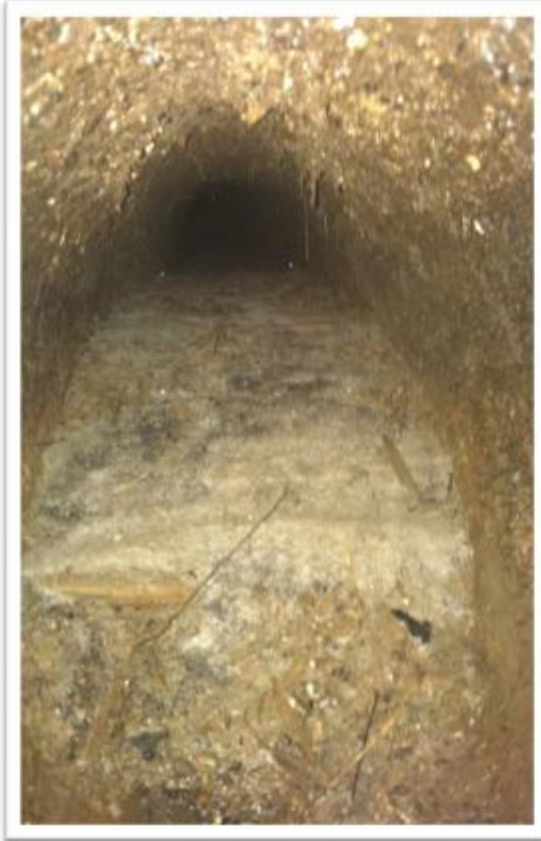
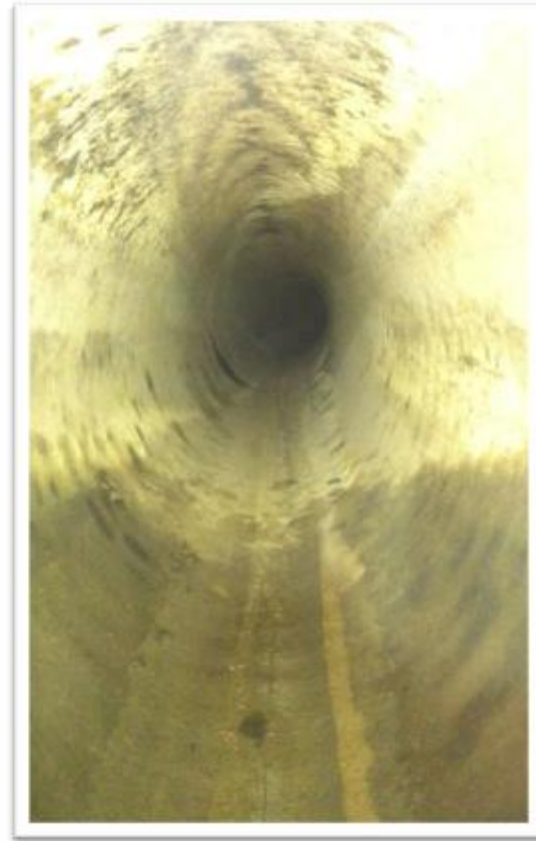
Storm Drain Interior Before and After Sediment Removal

Before Cleaning

After Cleaning

- Closed-circuit television inspection of the facility storm drain system was conducted to determine current conditions. Based on the investigation, Pepco removed accumulated sediments from the drainage system (which may have been a continued source of contamination), and repaired minor structural defects (***Completed in August 2015***)
 - 47 cubic yards of sediment was removed. The sediment was tested and found to be non-hazardous based on regulatory definition for waste disposal
 - Disposed of at an approved off-site facility
- Cooling Tower concrete basins and impacted soil removal (***Scheduled to begin in April 2016***)
 - Complete removal and off-site disposal of concrete basins – approximately 4,600 tons of PCB-contaminated concrete
 - Excavation and off-site disposal of approximately 7,900 tons of PCB-contaminated soil

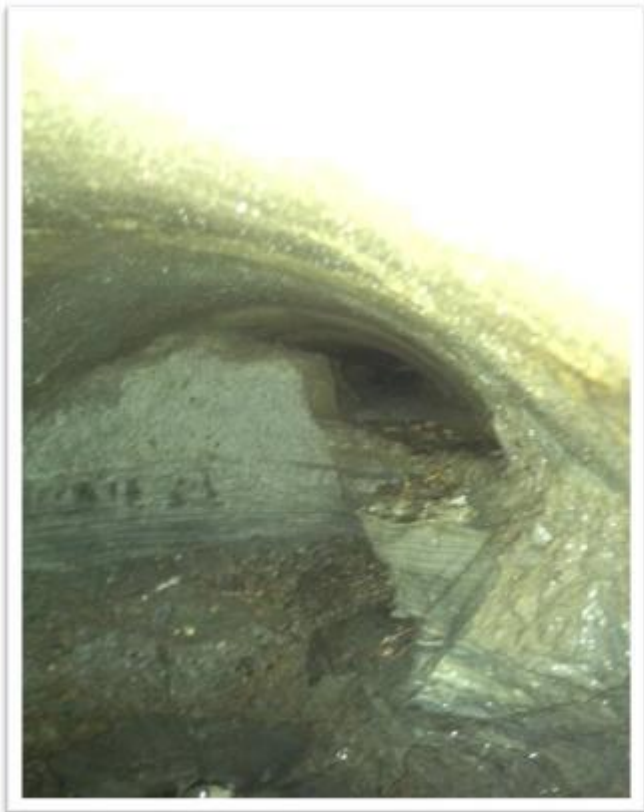
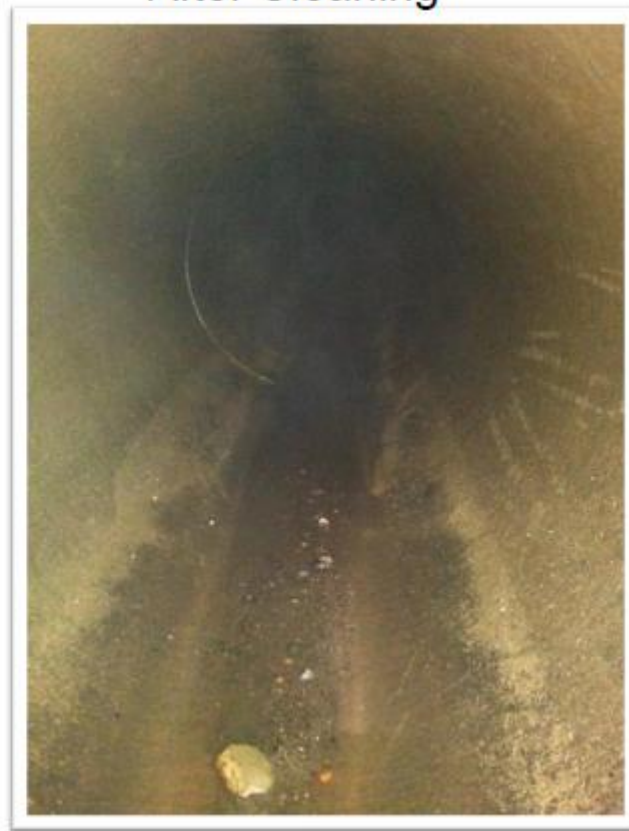
Storm Drain Interior Before and After Sediment Removal

Before Cleaning

After Cleaning
