Remedial Investigation/Feasibility Study (RI/FS) Project Update

Pepco Benning Road Facility

Presented by: Ravi Damera, AECOM Project Manager
Betsy Ruffle, AECOM Lead Risk Assessor

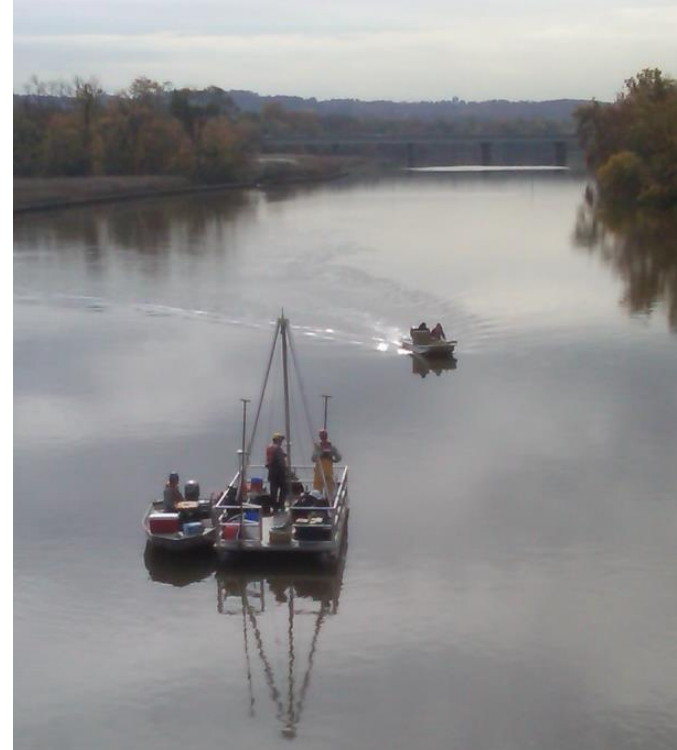
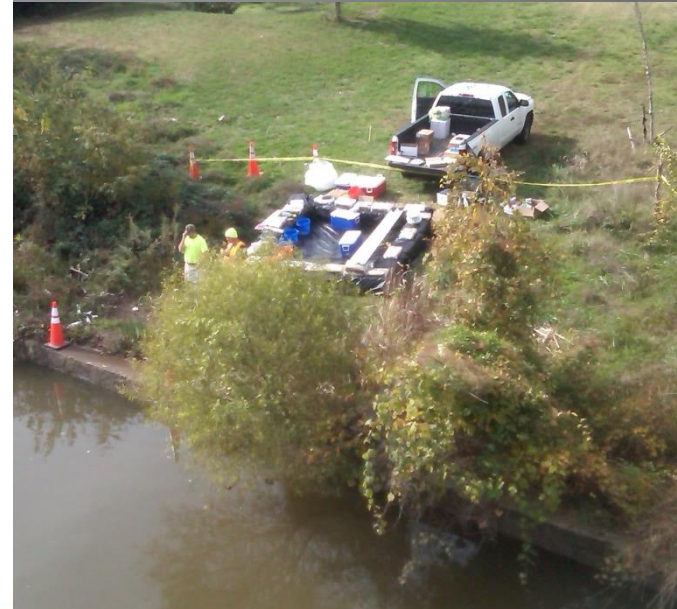
Total PCBs (ug/kg)

- River bottom survey to determine location and depth of river channel and identify buried utilities and debris.
- Collected 20 water samples and approximately 449 sediment samples from over 90 locations.
- Water and sediment sampling using barge or boat mounted equipment to ~ 8-10 ft below the mudline.
- Conducted pore water sampling, benthic macroinvertebrate surveys, and toxicity testing at 20 locations within the waterside investigation area and upstream background locations.

- Surface water concentrations generally below screening levels and generally consistent with background conditions.
- Concentrations of several metals, pesticides, PAHs, and PCBs exceeded ecological screening levels in sediment in the Waterside Investigation Area. The highest concentrations of these constituents are generally located in the River Cove, into which Outfall 013 from the site and three other pipes not associated with the site discharge.
- Concentrations of most chemicals in surface sediment are consistent with background conditions, but surface sediment PCBs, particularly in the Cove, exceeded site-specific background concentrations.
- Waterside Investigation Area including the Cove is net depositional.
- These detections and the CSM framework are further subjected to a risk assessment to determine risks due to waterside contamination.

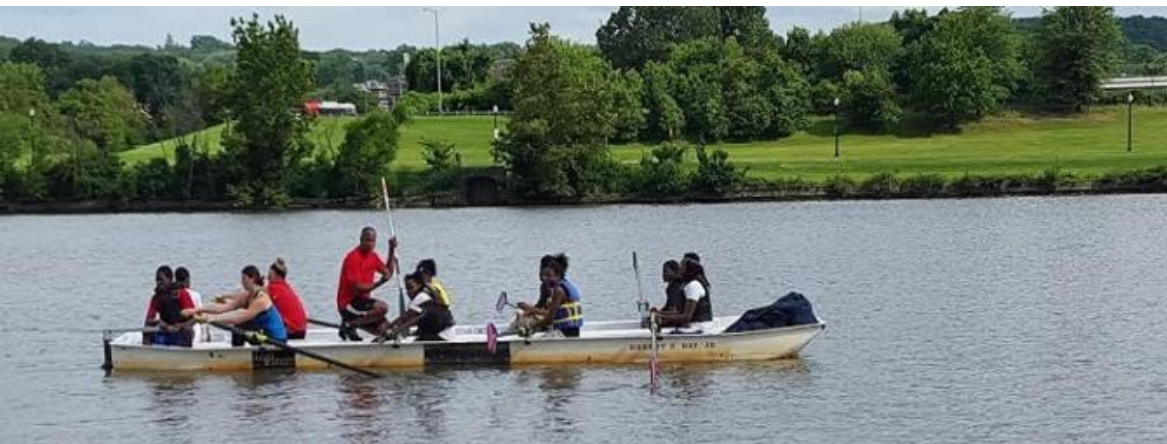
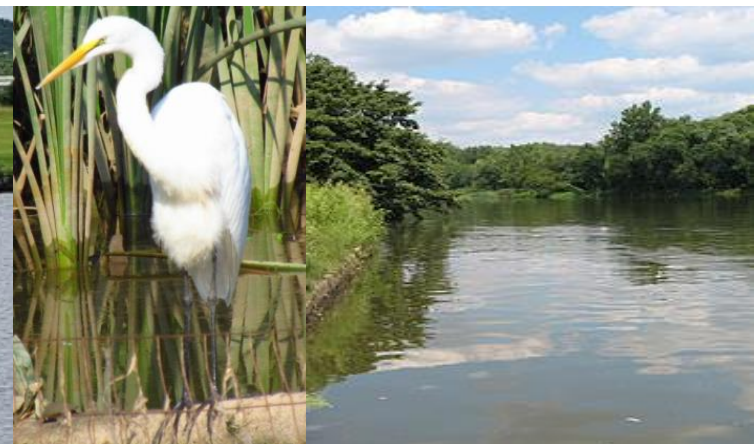
- Two types of risk assessments: Baseline Human Health Risk Assessment (BHHRA) and Baseline Ecological Risk Assessment (BERA)
- Objective: To evaluate exposure to chemicals in –
 - Landside soil and groundwater
 - Anacostia River surface water, sediment, and fish
- Conducted in accordance with guidance issued by the U.S. Environmental Protection Agency (EPA) for Superfund sites
